MARINE INVESTIGATION REPORT

M00W0230

FATAL ACCIDENT

FISHING VESSEL – TRAWLER “STAR QUEEN”

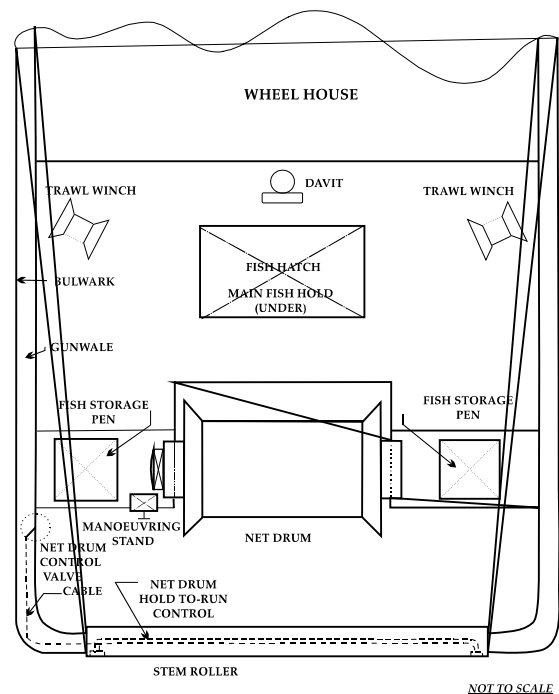
Figure 1. Sketch of the after deck

The working deck extends aft from the wheelhouse structure, to the stern of the trawler (see Figure 1). An hydraulically-operated boom is located abaft the wheelhouse, together with two hydraulic trawl winches, one on the port side and the other on starboard. A hatch for access to the main fish (cargo) hold, is located on the centre line, aft of the boom, and an open working space is aft of the hatch. The after deck area, part of which forms a well, is located under the drum of the main net storage winch. A second set of engine and rudder controls, used during fishing operations, are arranged on the port side, outboard of the winch. The control valve and handle to govern the speed and direction of rotation of the main winch motor is arranged under the bulwark on the port quarter.

A remote start/stop device (hold-to-run control) to the hydraulic winch motor is fitted under the bulwark around the stern. All the controls are arranged ergonomically around the operator's stand.

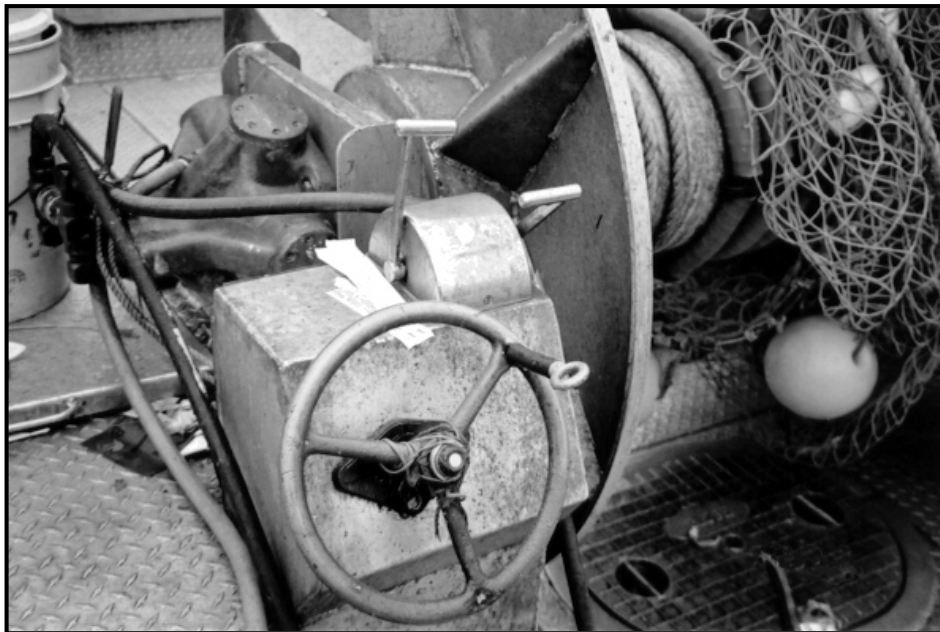
The bypass valve is mounted directly on top of the hydraulic motor itself, on the port side of the drum, and its handle is located between the two hydraulic pipes. It can be reached from the operator's stand described above. In addition, it can also be accessed by a person standing at the centre of the winch drum, when the net is fully deployed by reaching over and across towards the port side. This however, is a relatively awkward and inconvenient way of reaching it. There is no guard or protective plate between the side of the drum and the bypass valve.

The hydraulic winch controls were also controlled by a by-pass valve on top of the motor. This valve appears to have been installed to assist single-handed operation of the net launch and it cannot be considered a remote control device similar to the hold-to-run-control. When utilizing this by-pass valve, there is no hydraulic lock, and the winch can freewheel in either direction.

Photograph 2. Manoeuvring stand showing by-pass valve.

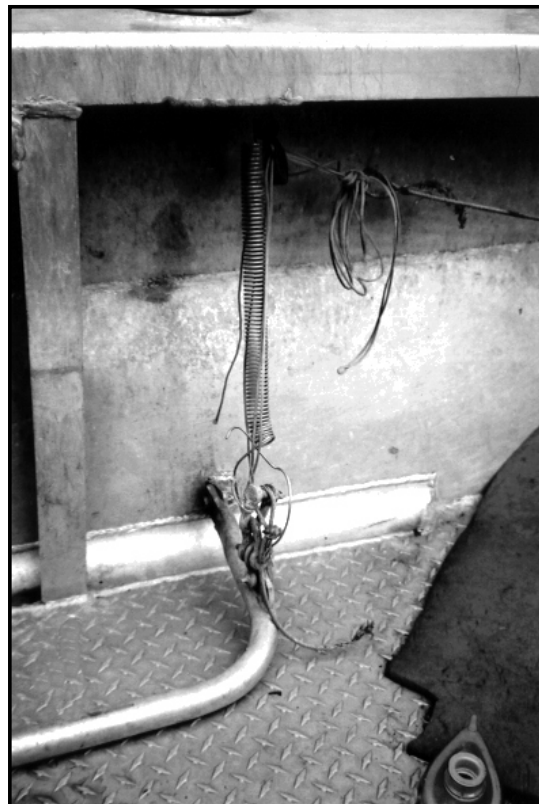
Prior to the occurrence, the hold-to-run-control of the "STAR QUEEN" had been disconnected from the winch control valve, leaving the emergency shut off device inoperative.

The winch control valve on the "STAR QUEEN" was found to be in a substandard condition. The valve had become sticky and hard to move; its internal resetting spring did not have sufficient tension to return the valve to neutral. Two external springs had been fitted in a makeshift arrangement to increase the resetting force, but these too had eventually become ineffective. In the end, since the hold-to-run-control could not have been used to regulate the valve, it had been disconnected.

1. The hold-to-run-control had been disconnected. There was thus, no automatic remote means of stopping the winch in the event of the operator becoming incapacitated.
2. The control valve for the hydraulic winch did not move freely and it did not automatically return to the neutral or stop position.
3. With no automatic resetting action available, the control valve would remain where it was positioned, and the winch would continue to turn until the control valve would be brought back manually to the neutral position. The winch continued to turn unchecked, once the owner/operator left the control stand to work the deck.
4. It is probable that the owner/operator's loose clothing became entangled in the net or warp and that he was drawn into the turning winch drum.

Photograph 4. Disconnected remote stop device (hold-to-run control).
